POLLUTION REPORT

Date: October 15, 2001
Subject: Coeur d'Alene River Basin Removal Actions, 2001 Construction Season
From: Bill Longston, OSC, USEPA, Region 10, Emergency Response Unit
Carl Kitz, OSC, USEPA, Region 10, Emergency Response Unit
Tel: Bill Longston Office (206) 553-1679
Carl Kitz Office (206) 553-1671
TO: See Distribution List on last page

POLREP No.2

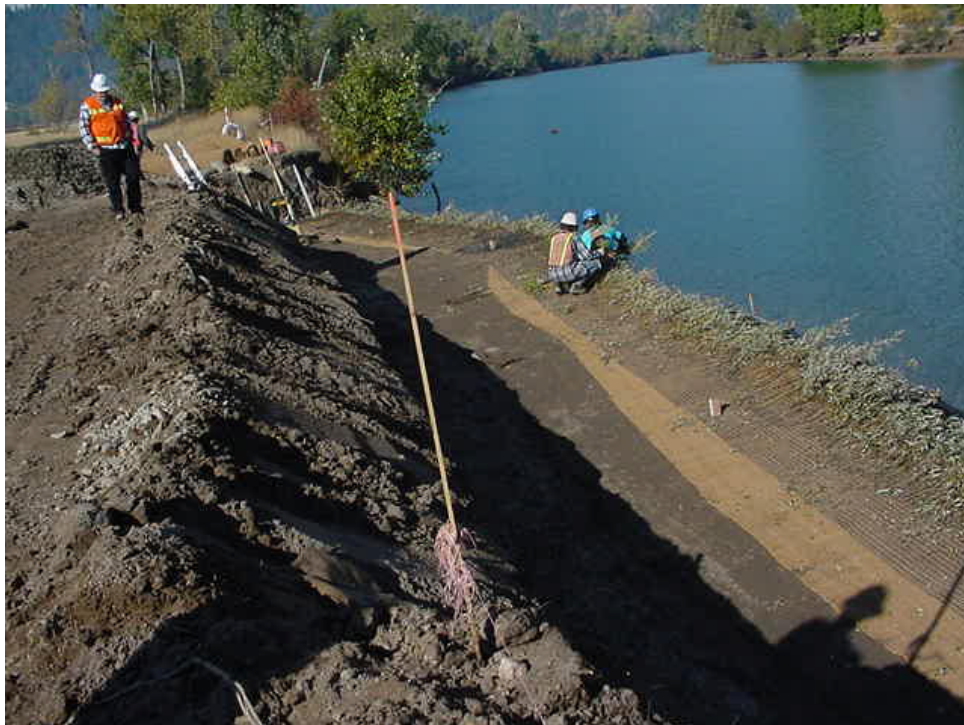
Highway 3 Streambank Stabilization, Layer 4: placement of vegetative whips over geo-grid reinforcements.

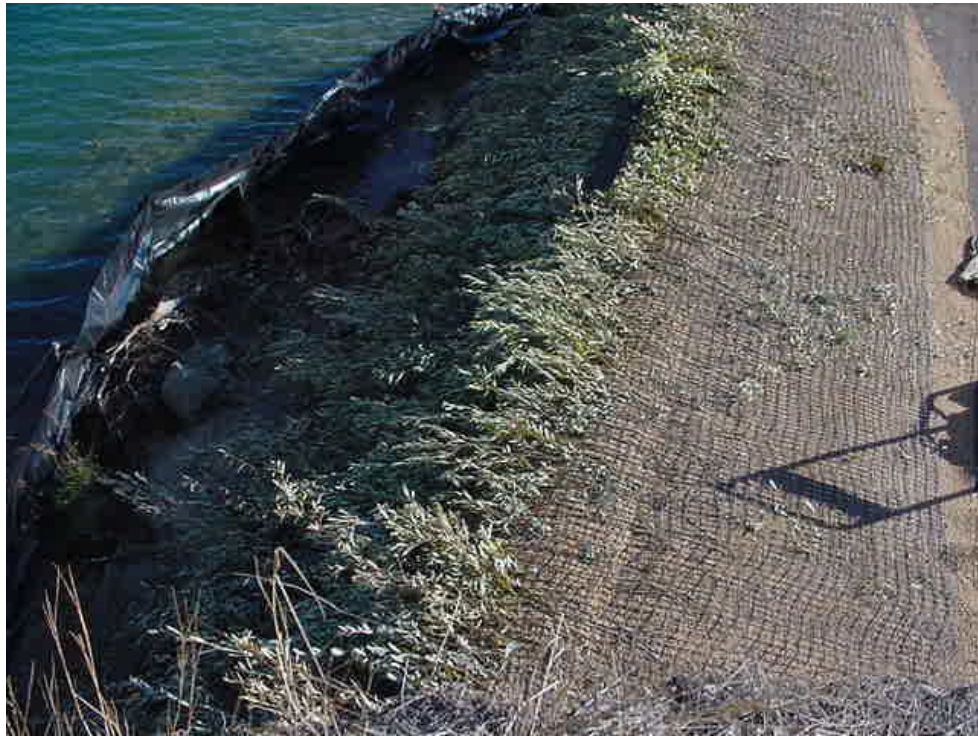
Highway 3 Streambank Stabilization, Layer 4: vegetative whips, geogrid reinforcement. Note sedimentation fence at base of wall and river.

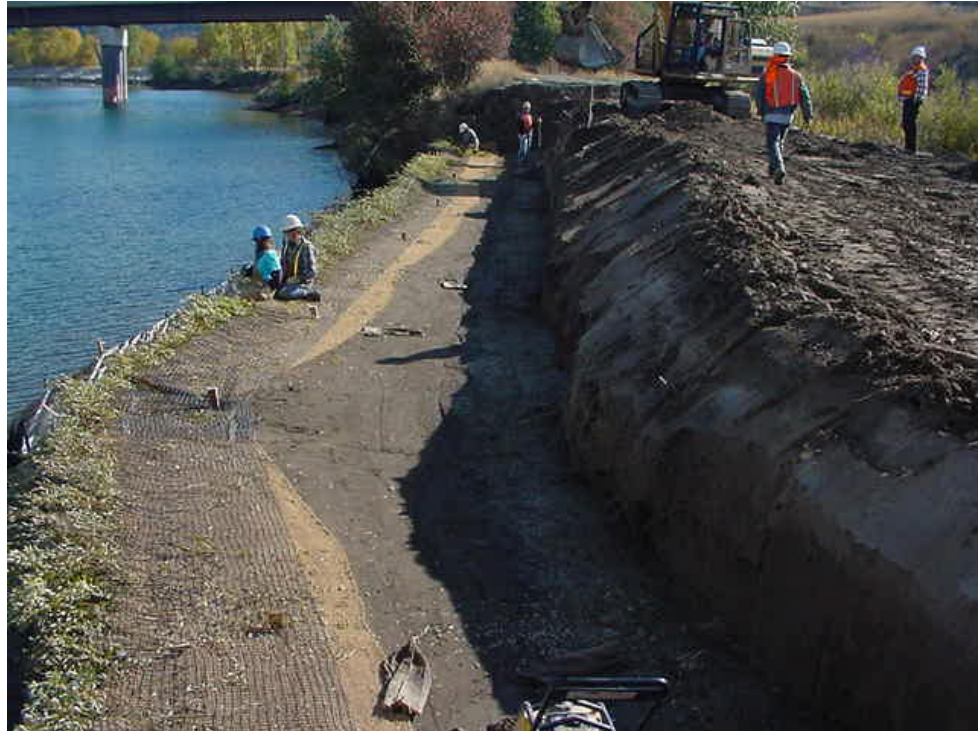
Highway 3 Streambank Stabilization, layer 4: View downstream
